# **Assessment of Dam Safety of Coal Combustion Surface Impoundments**

**Indianapolis Power & Light Company**

**Petersburg Generating Station**

**November 15, 2010**

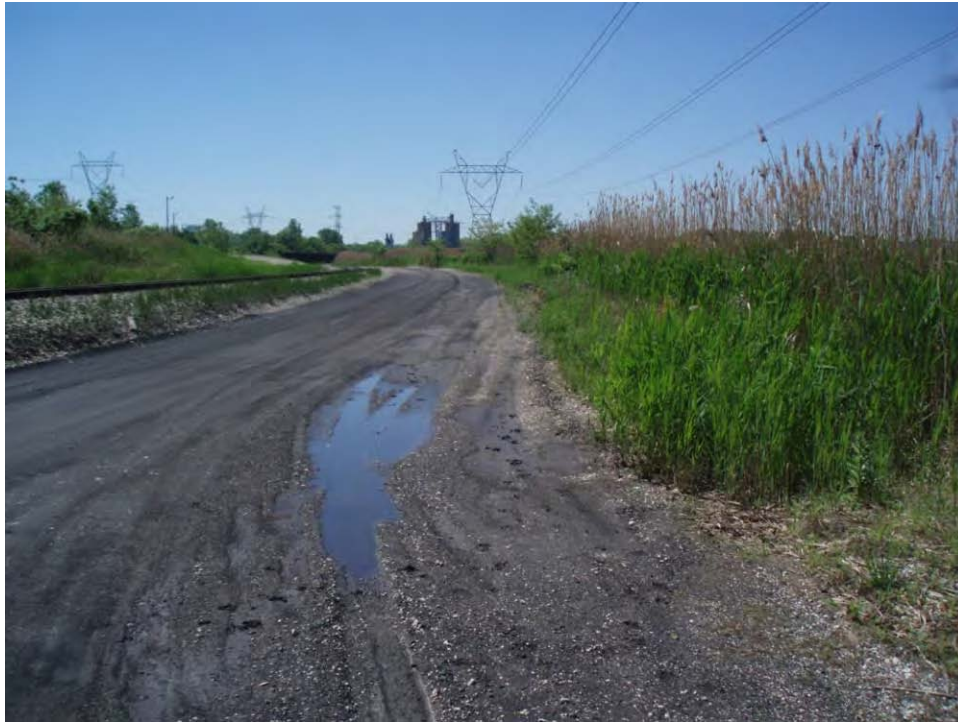
The crest of Pond A generally appeared to be in fair condition (Photos 1, 3, 4, 9, 10, 11, 12, 14, 49, 62, and 64). The crest was approximately 20 feet wide. The crest is surfaced with a compacted gravel access road on the north and east embankments. The crest on the south and west embankments were generally covered with grass approximately 6 to 12 inches tall. The crest around the sluice pipes on the south embankment was covered with ash (Photos 12 and 14). An access ramp excavated into the crest near the sluice pipes on the south embankment was observed (Photo 10 and 12). Track marks from an excavator were observed on the crest of the west embankment (Photos 26, 27, and 29).

1. Pond A – East embankment crest, looking south.

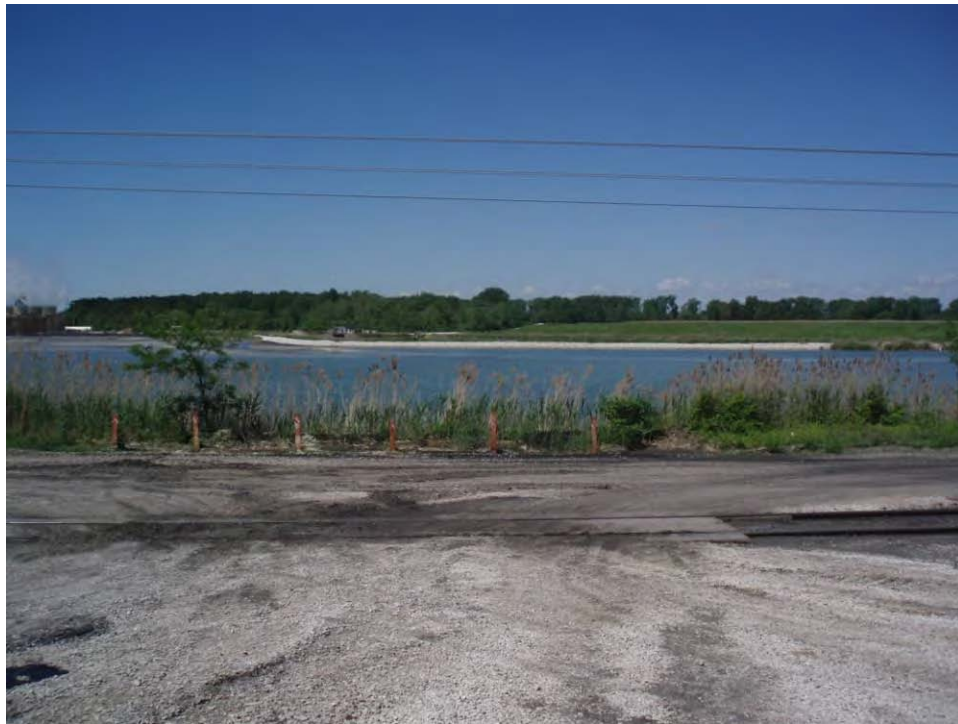
The visible portions of the interior slope generally appeared to be in fair condition (Photos 2, 6, 7, 9, 16, 17, 20, 21, 29, 30, 31, 32, 39, and 48). Tall, thick wetland-type vegetation up to 8 to 10 feet tall obscured the observation of north and east embankment as well as the divider embankment. The north and west interior slope of the divider embankment generally appeared to be armored with a layer of riprap armor.

2. Overview of Pond A and east slope of divider embankment, looking west

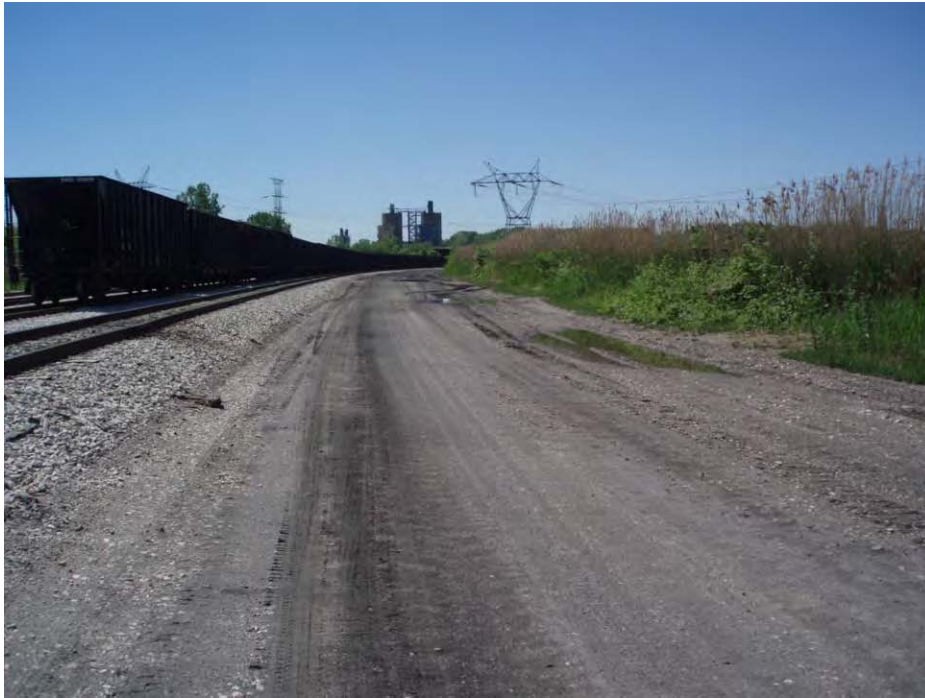
3. Pond A – East embankment crest, looking south.

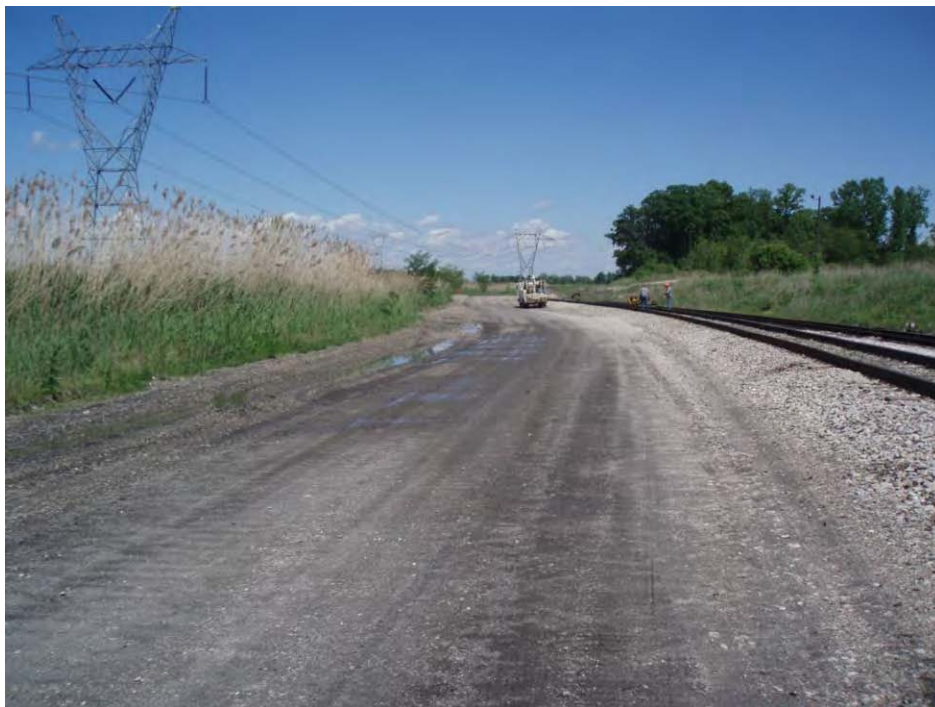
4. Pond A – East embankment crest, looking north

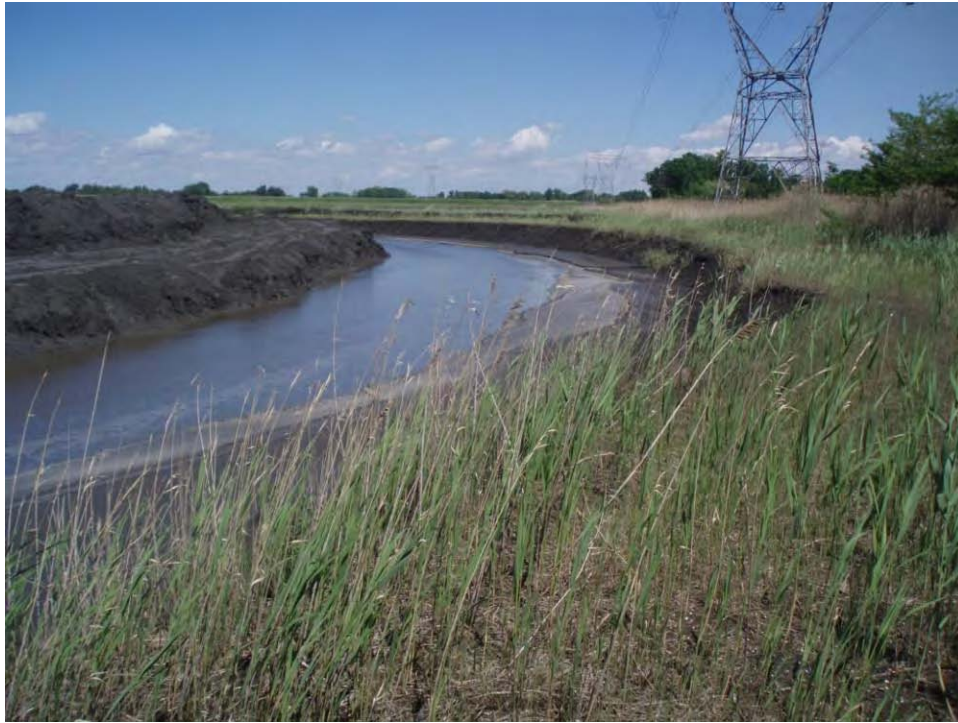
two (2) 36-inch-diameter and five (5) 10-inch-diameter ductile iron (DI) pipes sluice CCW into the impoundment (Photos 7 and 8). A rim ditch (Photos 5, 6, and 7) excavated adjacent to the south and east interior slope diverts flow, increasing the settling time of materials in the impoundment. Along the west embankment one (1) 12-inch-diameter DI and two (2) 8-inch-diameter stainless steel (SS) pipes sluice other liquids into the impoundment (Photo 20). At a headwall located at the western abutment of the divider embankment between Pond A and Pond A – Discharge, two (2) 24-inch-diameter reinforced concrete pipes (RCPs) and one (1) 4-inch-diameter DI pipes sluice other wastes into Pond A (Photo 36). Pond A is connected to Pond A – Discharge through two (2) 36-inch-diameter CMPs (Photo 45). Pond A – Discharge is used as a secondary settling basin prior to water being discharged at the outlet structure or being diverted into the recycling pump station. The outlet structure consists of a box structure with stoplogs and a 24-inch-diameter RCP with an invert elevation of El. 415.9.

5. Pond A rim ditch, looking north.

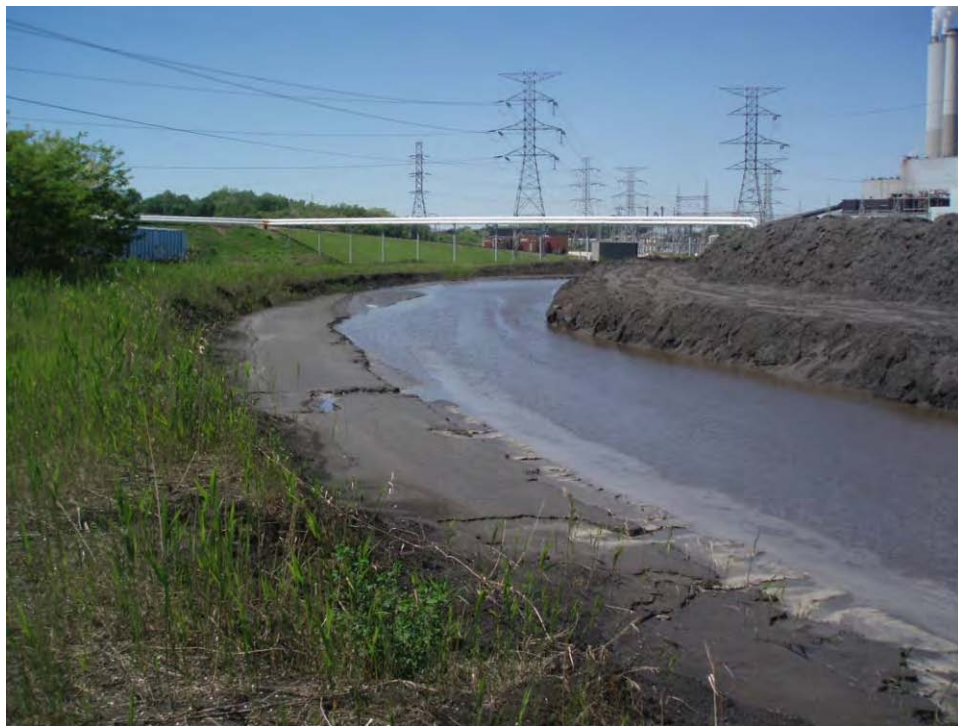
6. Pond A rim ditch, looking southeast.

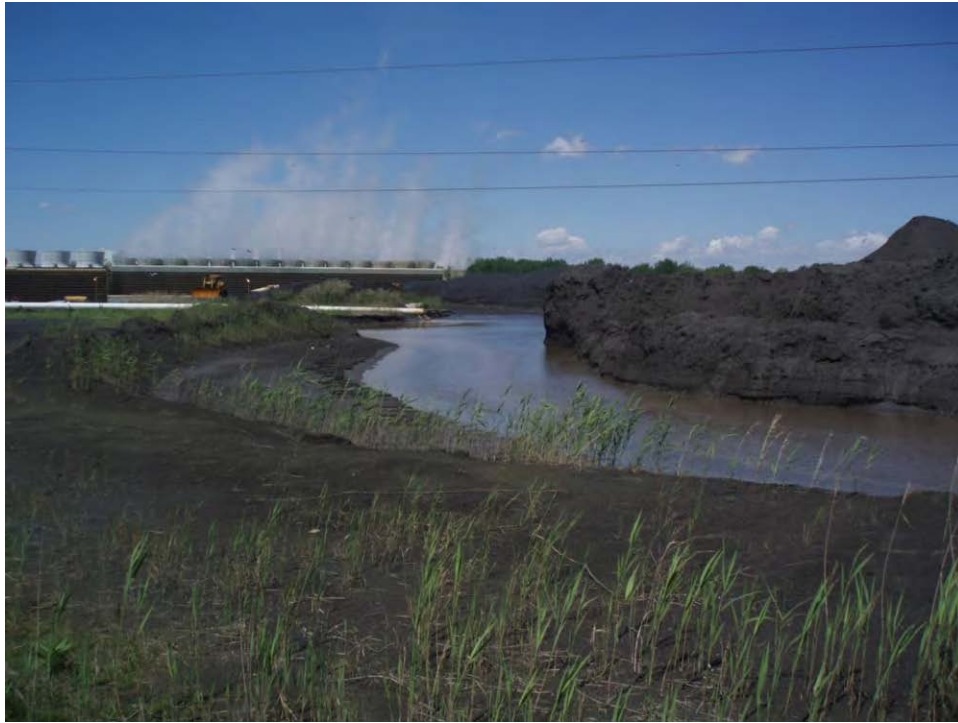
7. Pond A rim ditch looking west at sluice pipes.

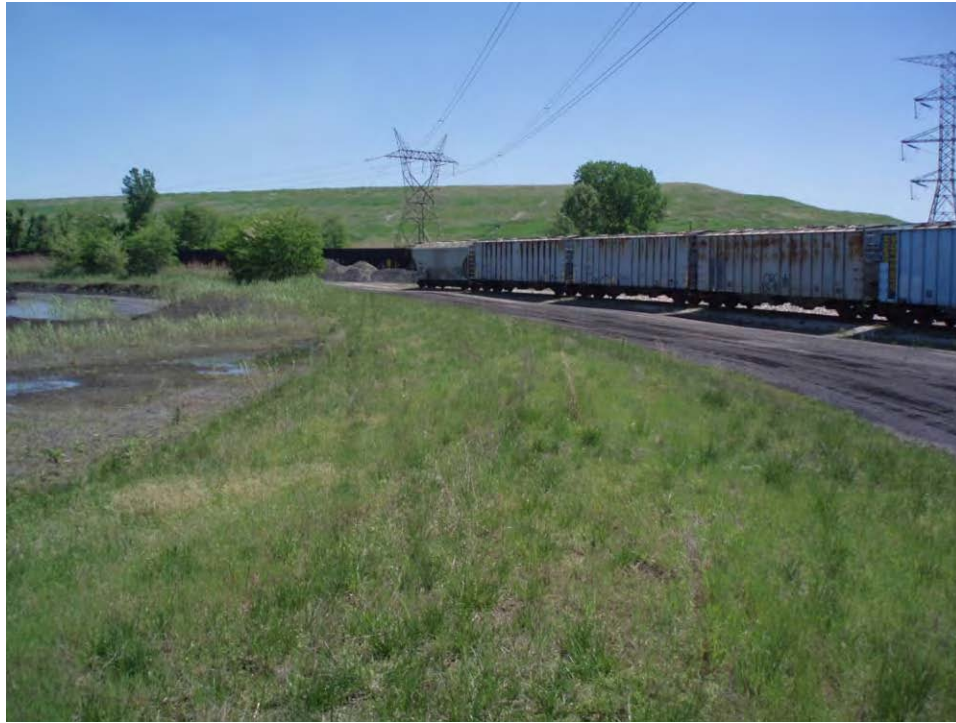
9. Pond A – South embankment crest, looking east.

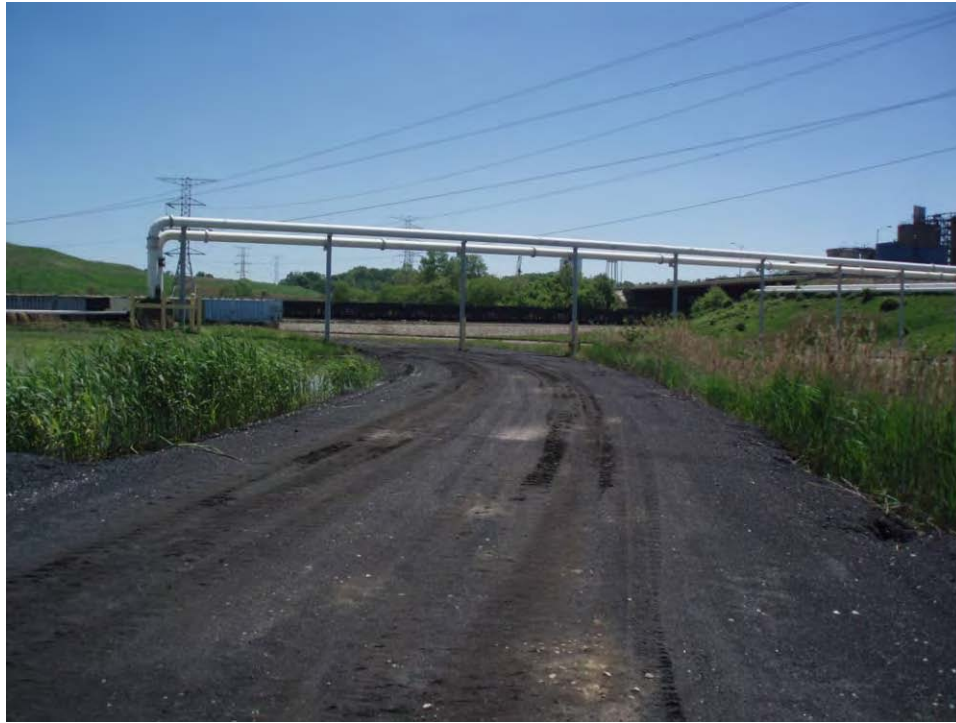
11. Pond A – South embankment looking southeast.

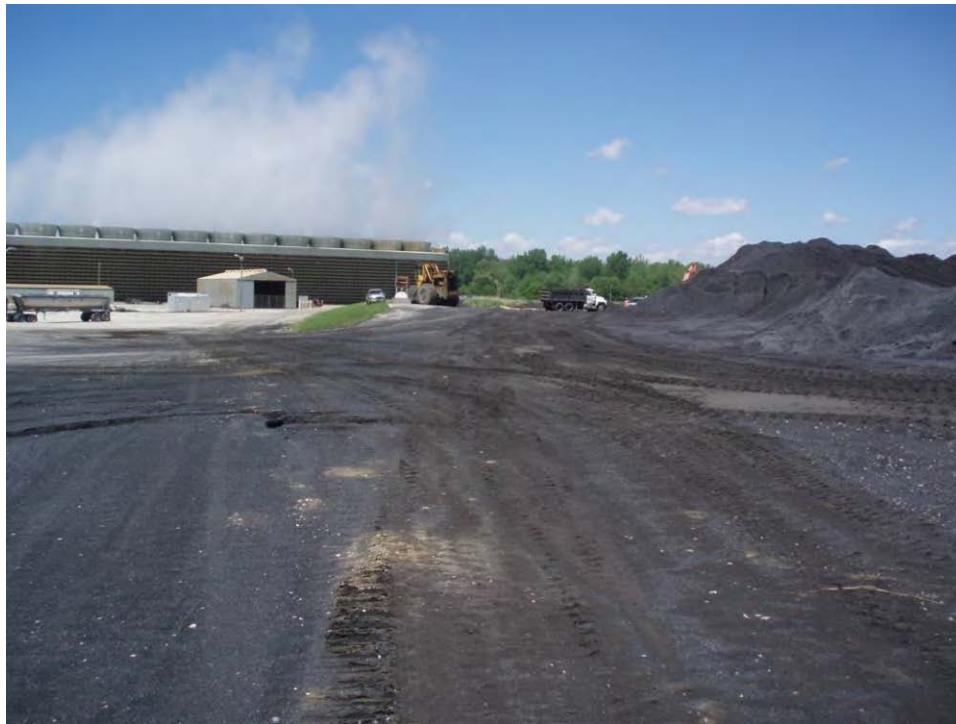
12. Pond A – South embankment crest, looking northwest.

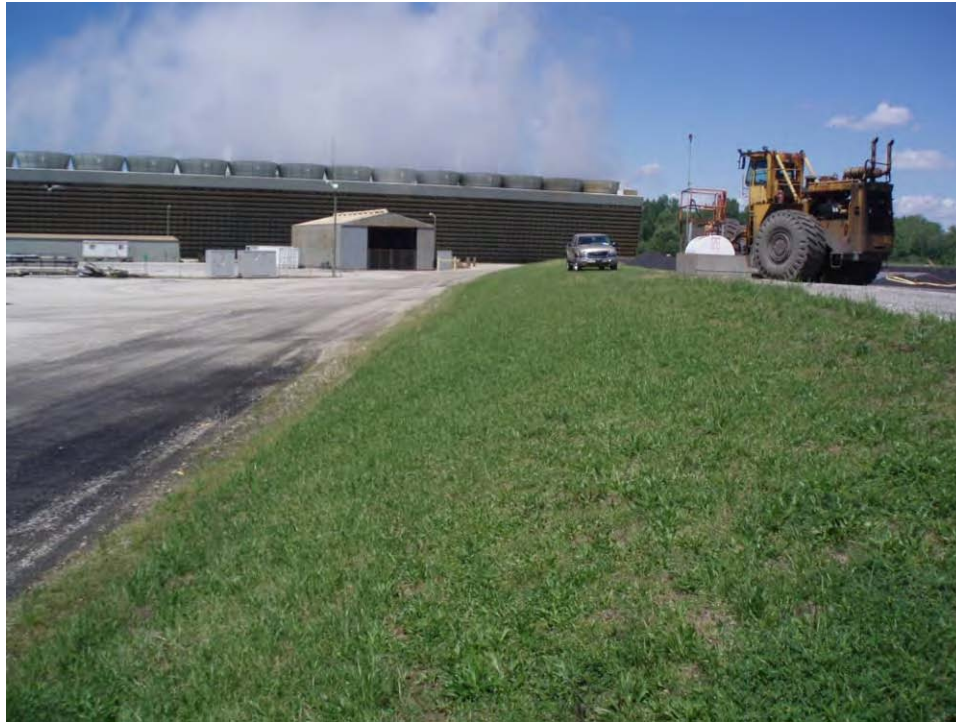
The exterior slopes appear to be in fair condition. The exterior slopes on the south and west embankments were approximately 3H:1V (Photos 13, 19, 22, 23, 24, 26, 27, 28, and 34). The north exterior slope on the divider embankment between Pond A and Pond A – Discharge was approximately 2H:1V (Photos 37 and 47).

13. Pond A - South embankment exterior slope, looking northwest.

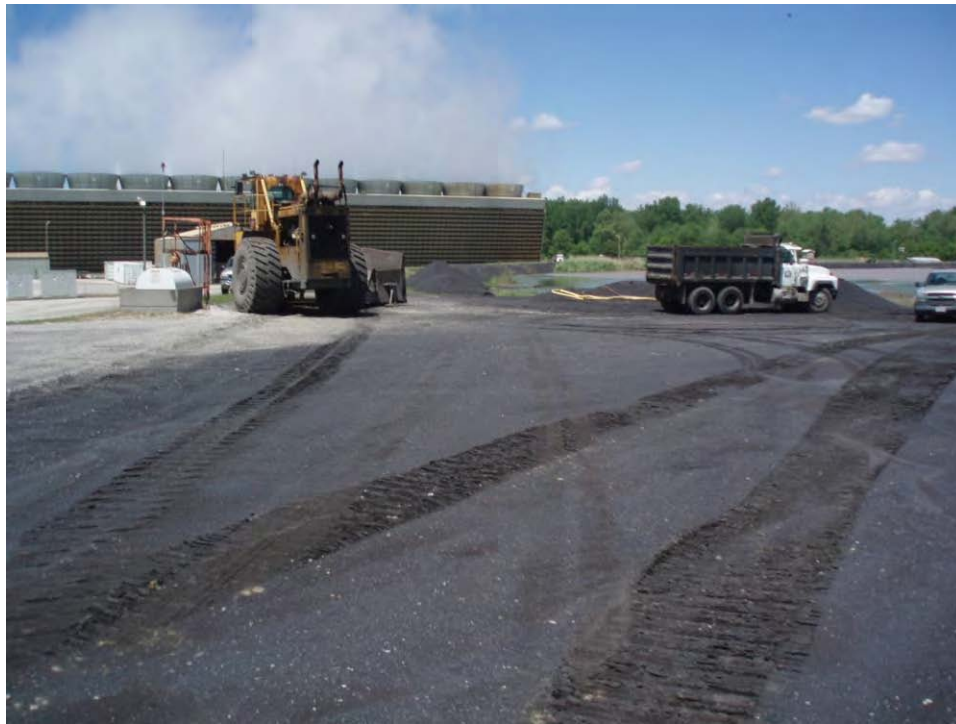
14. Pond A - South embankment crest, looking northwest.

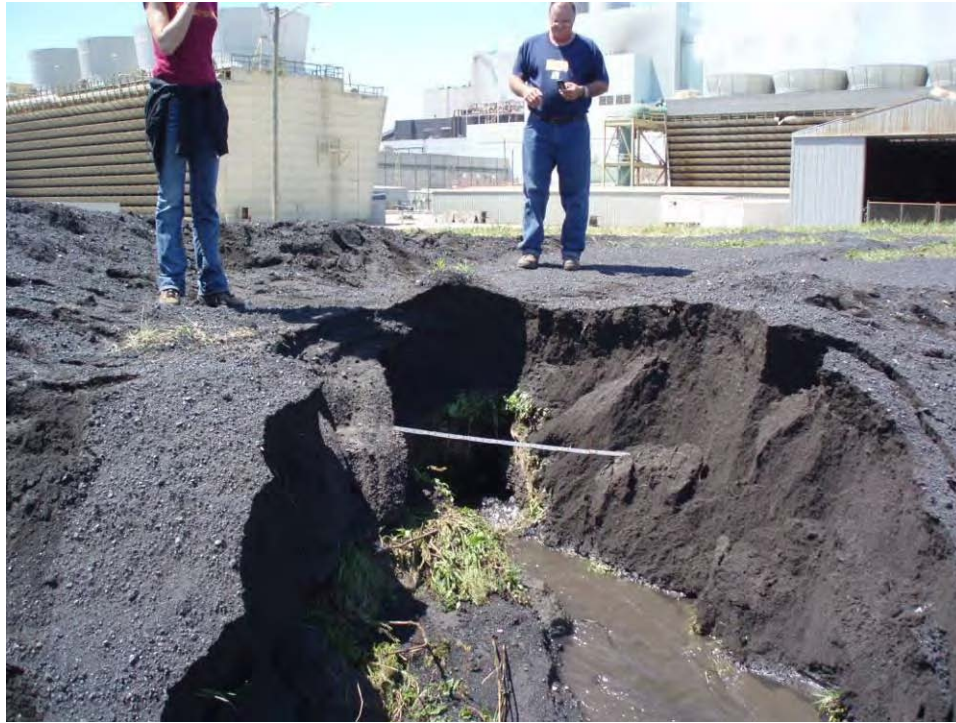
During the site visit, active piping/erosion of the crest was observed (Photo 15). The water had eroded the recently placed ash and formed an erosion cavity in the original embankment. The water was clear and had a constant estimated flow of 10 to 20 gpm. At the time of the site visit, IPL staff did not know the source of the water (i.e., if it was an unmarked pipeline in the embankment). The staff was in the process of identifying the source and addressing the situation. It is our understanding that after CDM's site visit IPL determined that the source of water was Unit #2 cooling tower blow down. It was reported by IPL that the erosion was addressed by placing riprap on the western and southern portions of Pond A's interior slope face, and that these corrective actions were completed on May 14, 2010.

15. Pond A – Active erosion/piping of south embankment interior slope from unknown water source. Water was clear. Eroded area 5'Wx8'Lx3.5'D. IPL personnel were trying to determine source of flow.

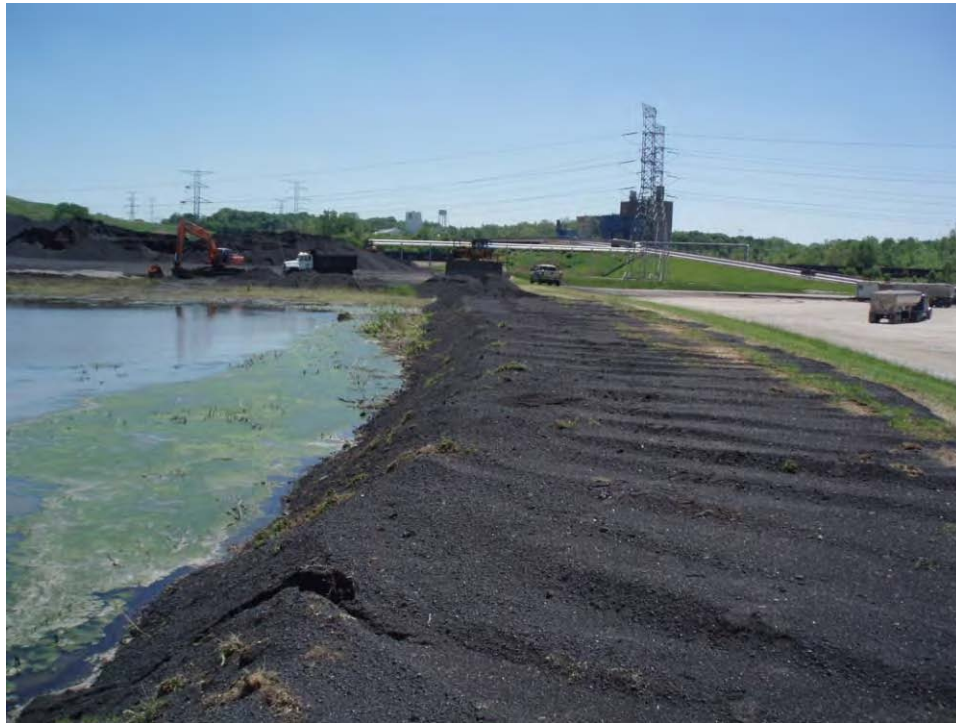
16. Pond A – South embankment crest, looking southeast at recently placed ash material. Note existing embankment was not cleared or grubbed before placing material.

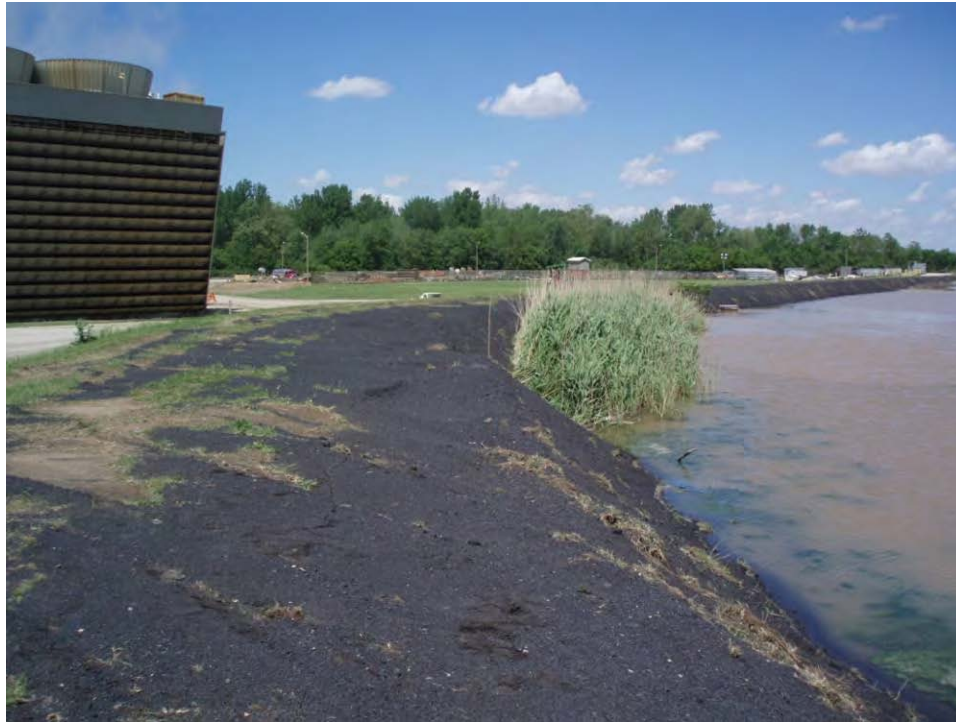
17. Pond A – South embankment crest, looking northwest at recently placed ash. Note existing embankment was not cleared or grubbed before placing material.

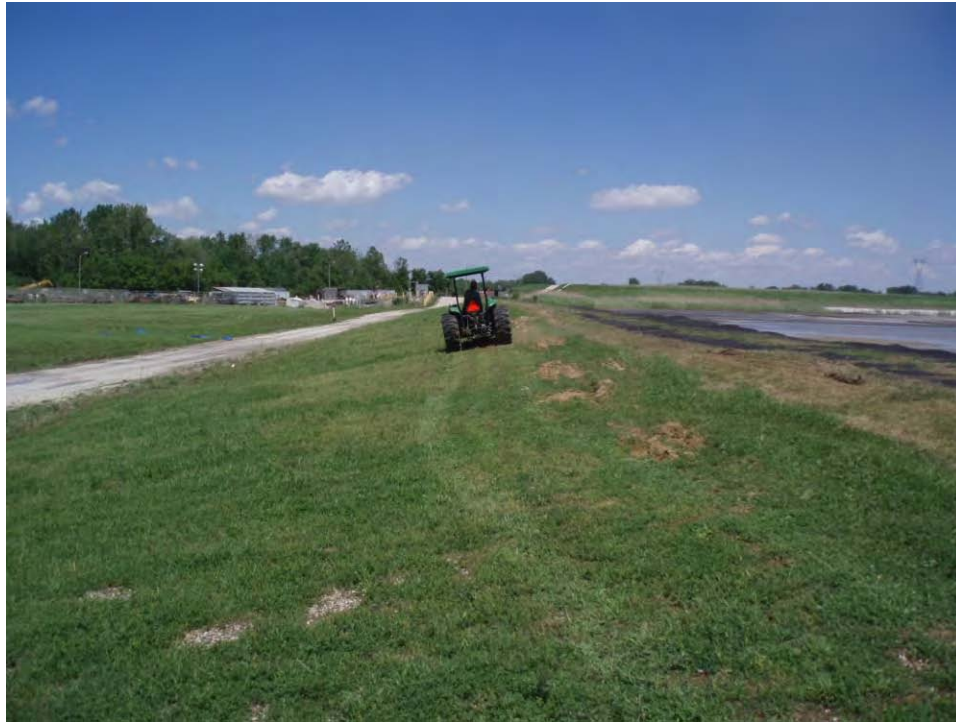
19. Pond A – West embankment exterior slope, looking north at mowing operation.

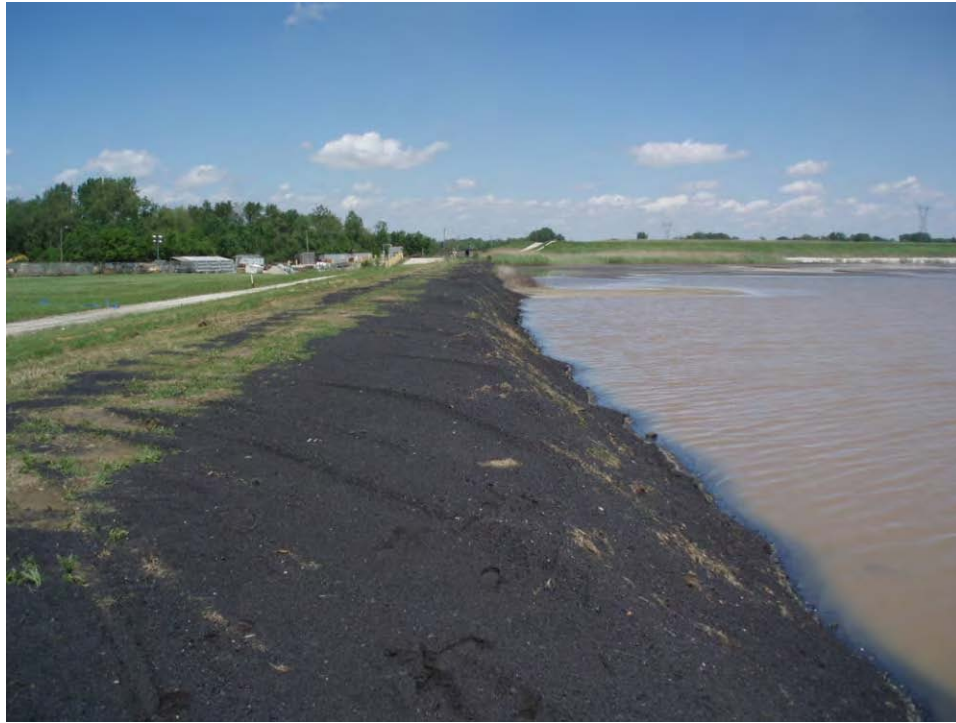
21. Pond A – West embankment interior slope and crest, looking north

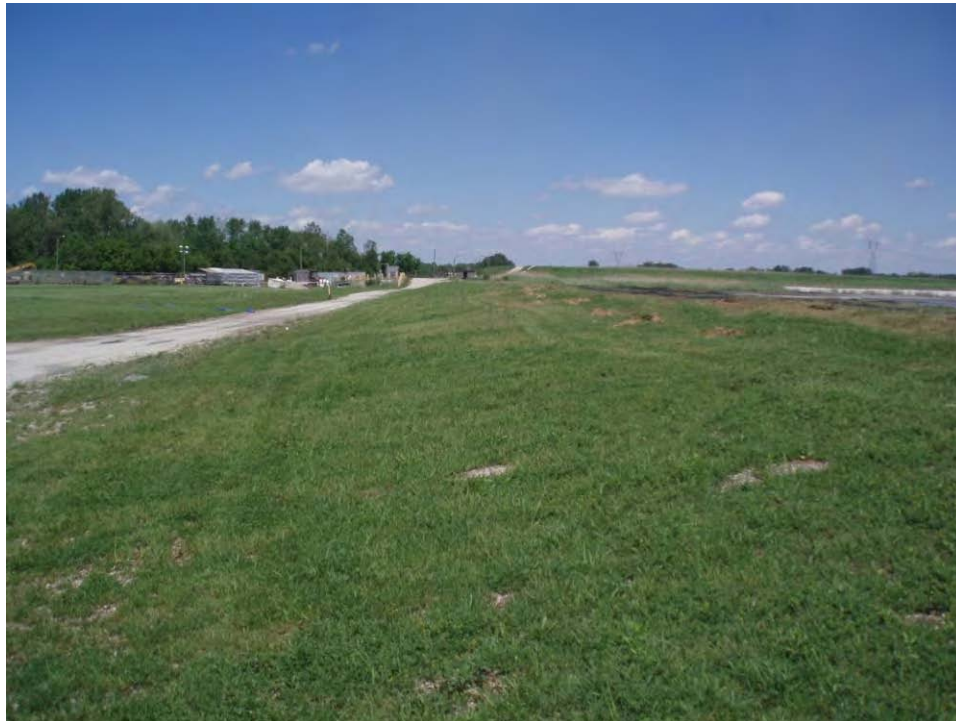
22. Pond A – West embankment exterior slope, looking north.

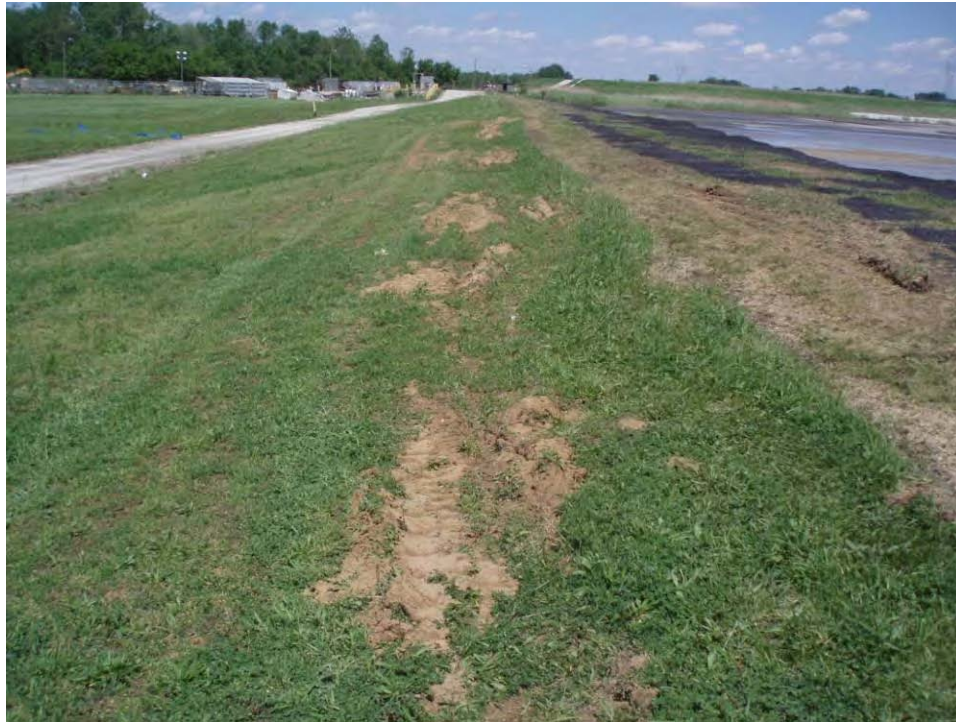
23. Pond A – West embankment exterior slope, looking north at tractor ruts.

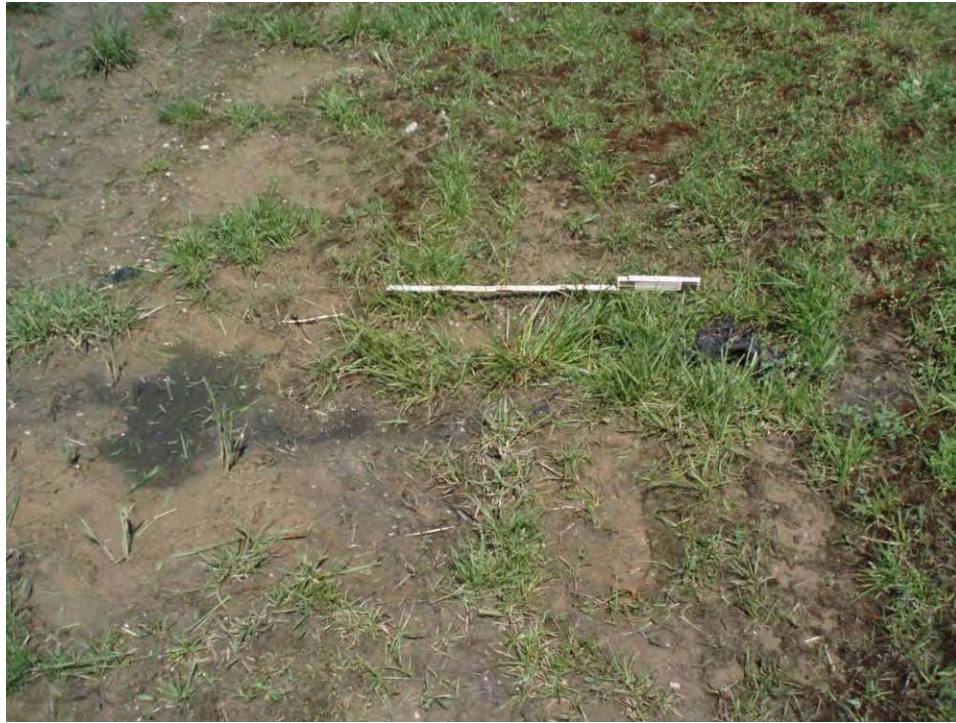
A possible seepage area was observed on the west embankment exterior slope (Photo 25).

25. Pond A – Saturated area on west embankment exterior slope.

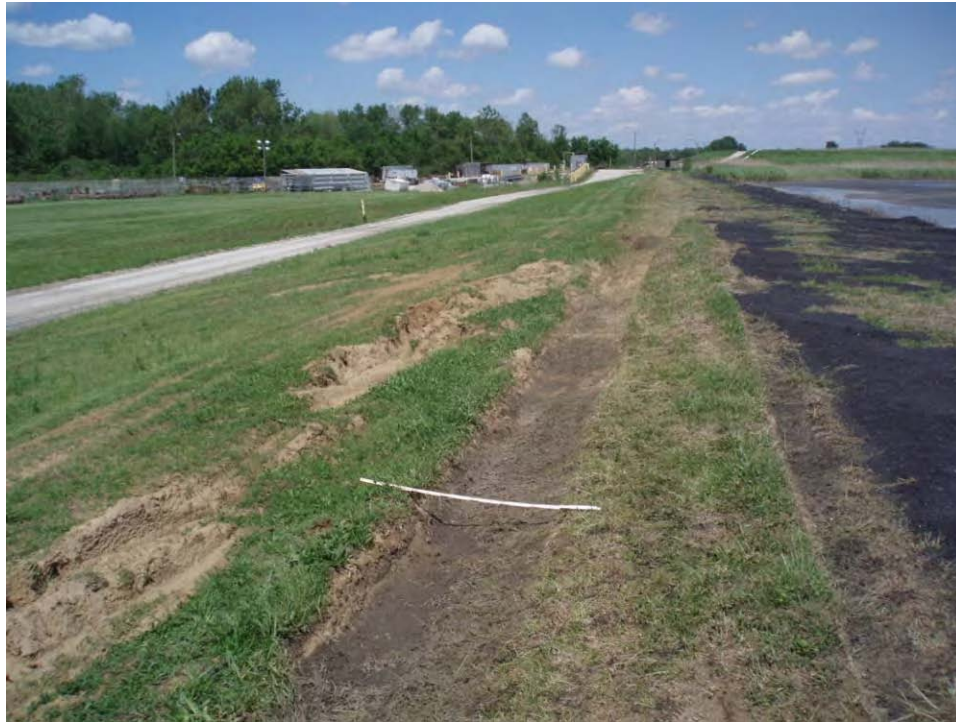
27. Pond A – West embankment exterior slope, looking north at large tractor ruts and excavator tracks.

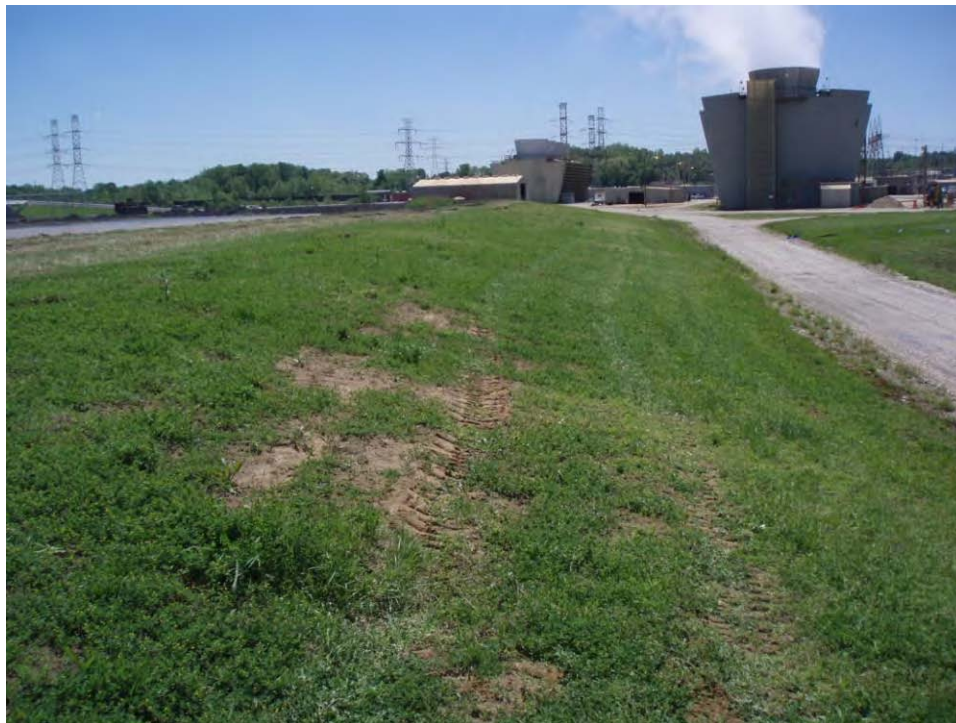
28. Pond A – West embankment exterior slope, looking south.

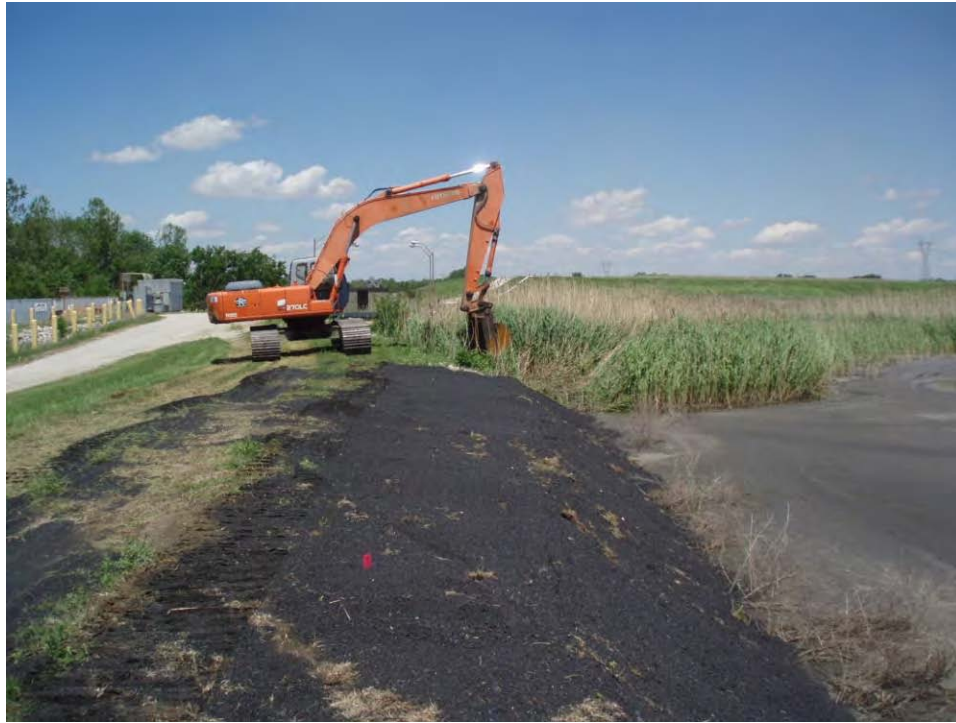
29. Pond A – West embankment interior slope looking north at embankment work.

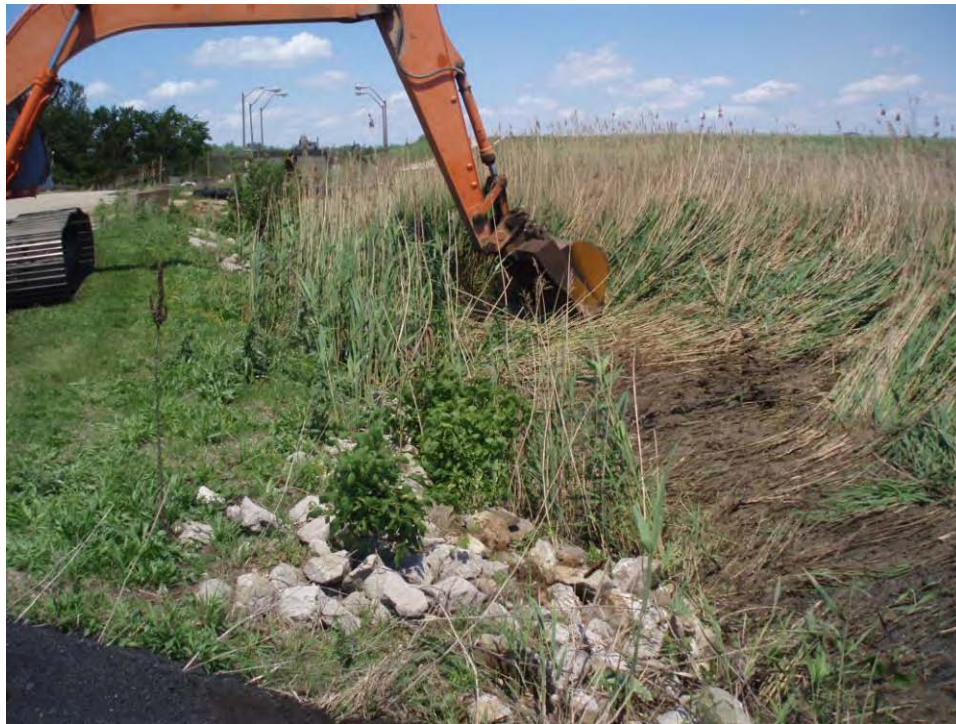
30. Pond A – West embankment interior slope, looking north at excavator flattening vegetation before placing ash material. Note an unknown 24-inch-diameter RC pipe in the embankment was being covered with ash.

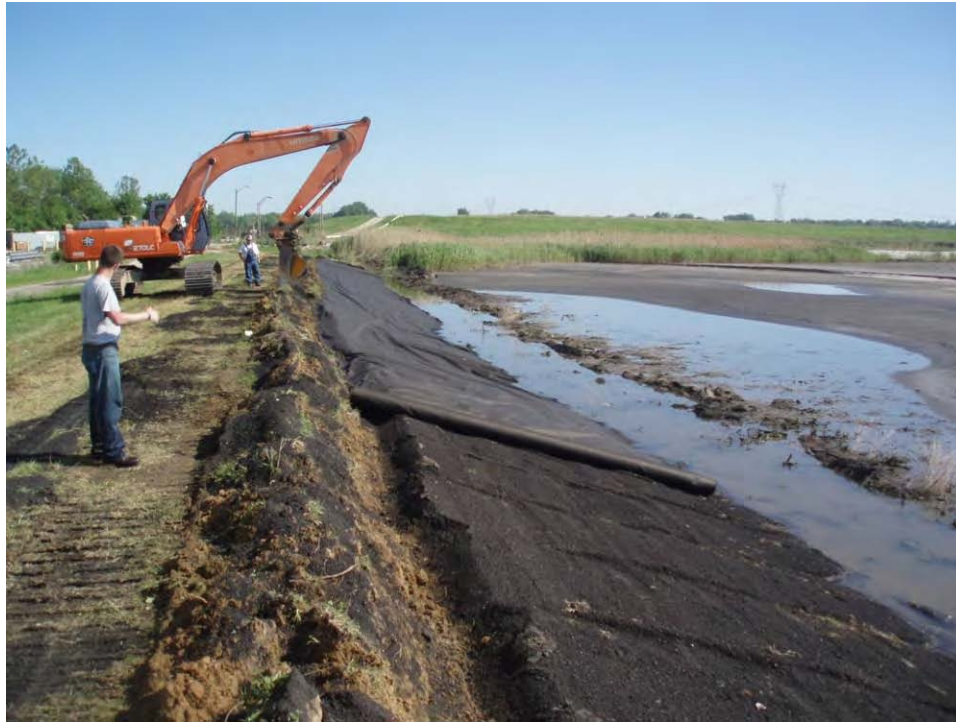
31. Pond A – West embankment interior slope, looking north at rough embankment grading. Note Mirafi geofabric does not extend to the toe of the slope.

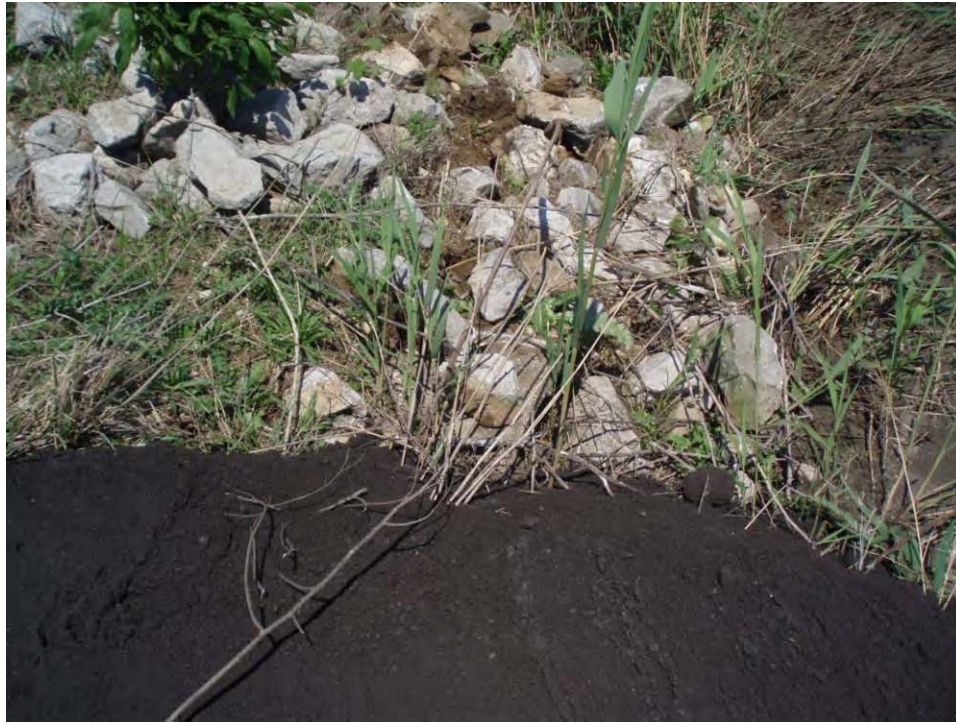
33. Pond A – 24-inch-diameter RC pipe being covered by ash.

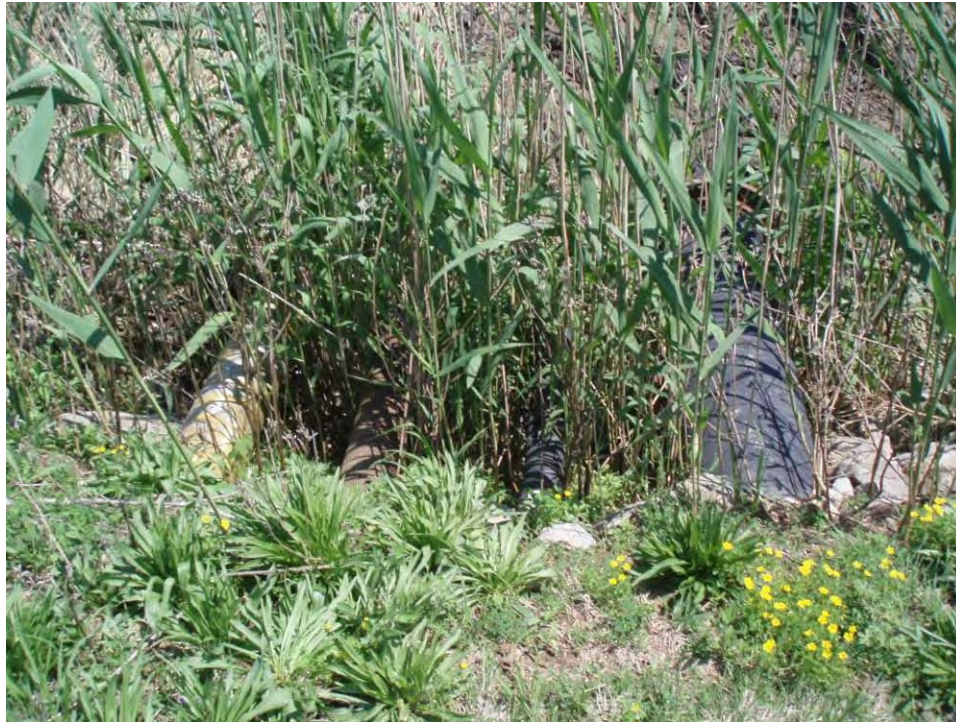
35. Pond A – Looking east at inactive 4-, 6-, 8-, and 15-inch-diameter sluice pipes from unknown origin. Use unknown.

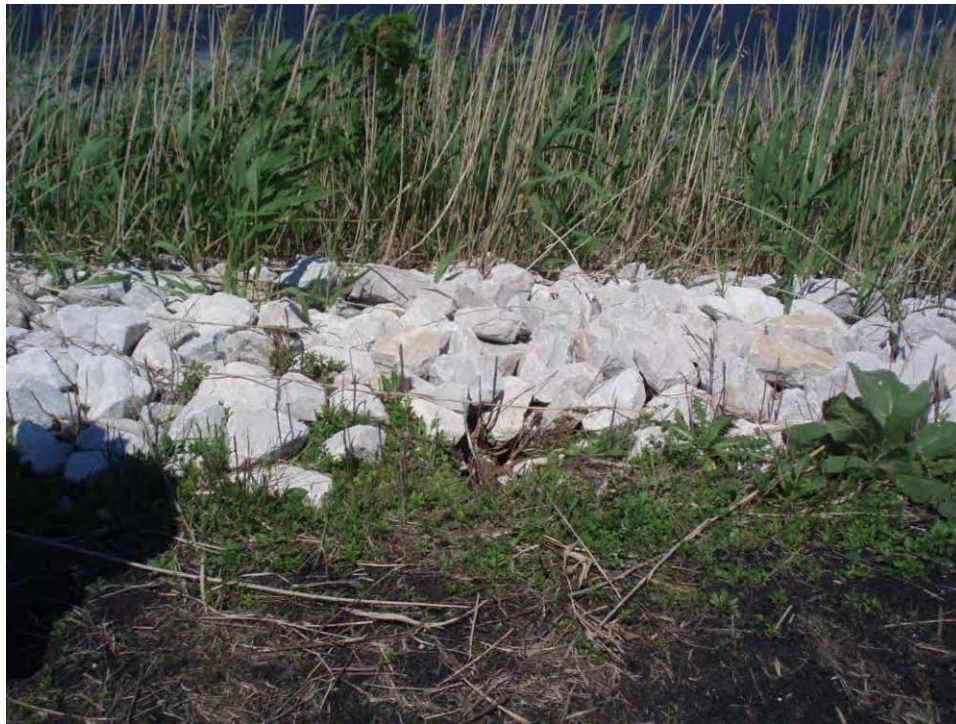
40. Surficial erosion under riprap on north slope of divider embankment between Pond A and Pond A - Discharge.

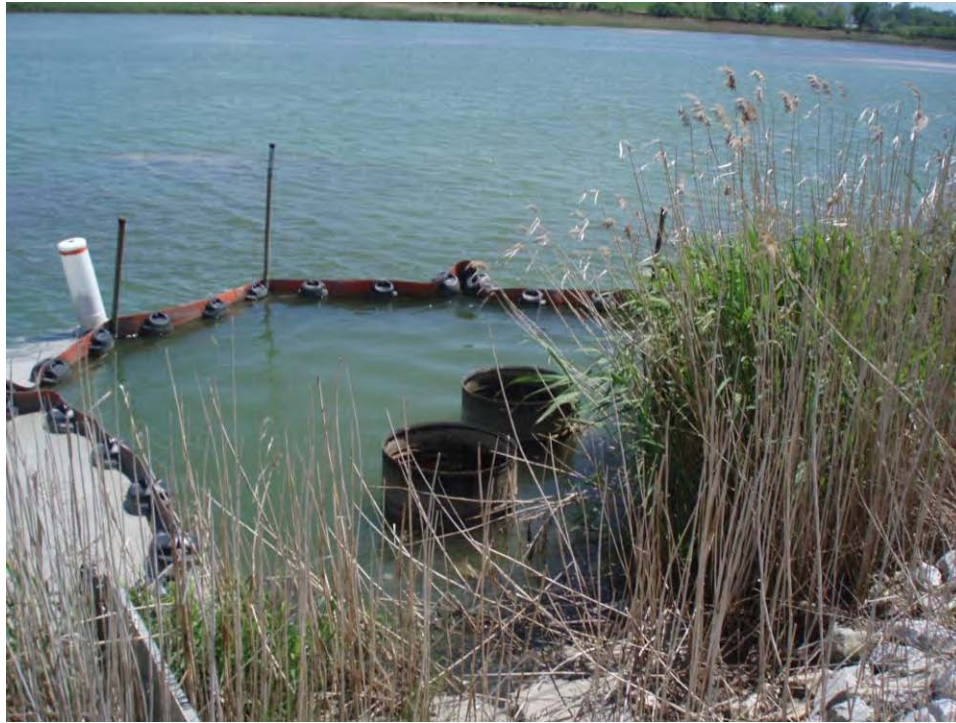
45. Inlet of two (2) 36-inch-diameter CM pipes from Pond A to Pond A - Discharge. Note pipes have T's at inlets and the floating boom to reduce the potential for surface debris from clogging pipes.

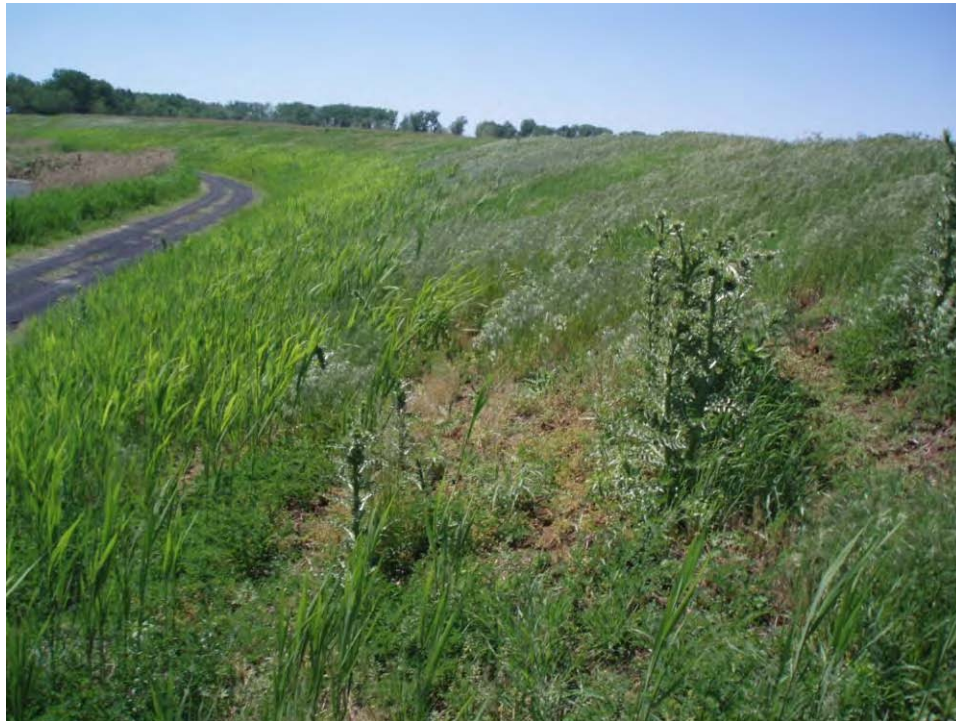
58. Pond B - South embankment exterior slope, looking west at tractor rutting and minor surficial erosion. Note change in vegetation at mid slope and stabilized FGD material very soft.

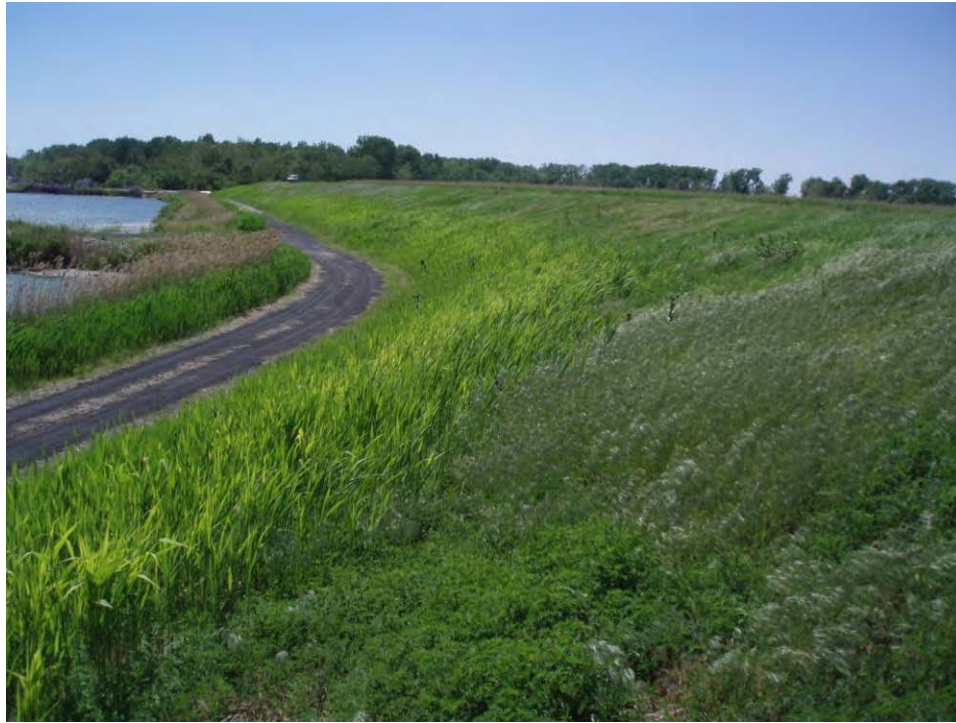
59. Pond B - South embankment exterior slope, looking west. Note change in vegetation at mid slope and stabilized FGD material is very soft.
